ECODRIVE DKC01.1/DKC11.1 Drive Controllers

Trouble Shooting Guide: ASE 04VRS

Type of documentation Trouble Shooting Guide

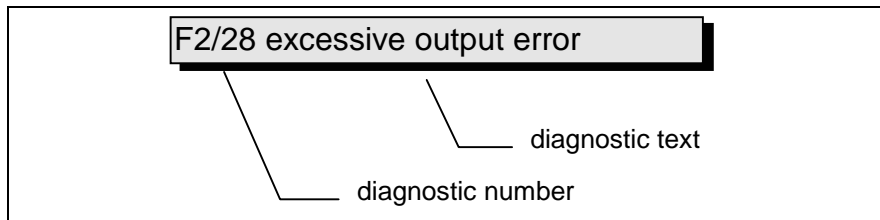
Fig. 1-1: Construction of a diagnostic message from a diagnostic number and a diagnostic text.

In the example shown, the "F2" and "28" alternate on the H1 display.

The clear coded text-diagnostic message contains the diagnostic number followed by the diagnostic text; for example, "excessive output error" (Fig 1-1). It can be read from parameter **"S-0-0095, diagnostic message"** and serves the direct display of the process state on a operator surface.

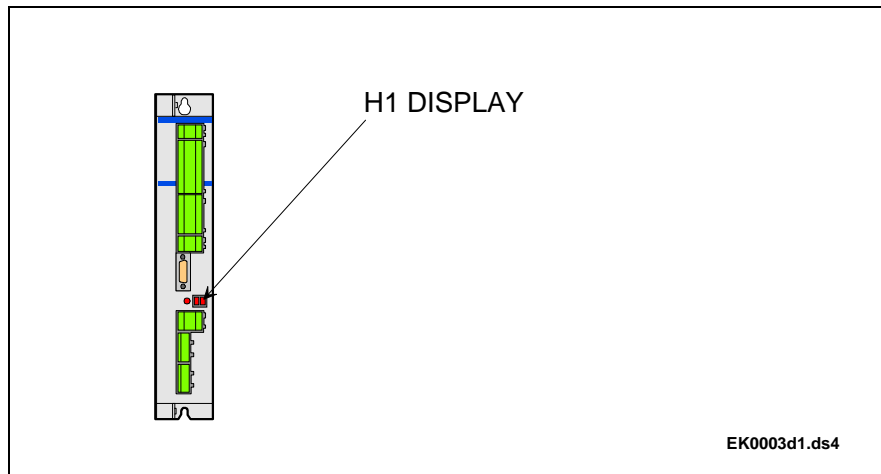
Fig. 1-2: H1-Display

The symbolized diagnostic number appears on this two positional-seven segment display. The form of the display is seen on the diagram "Priority dependent diagnostic message diagram."

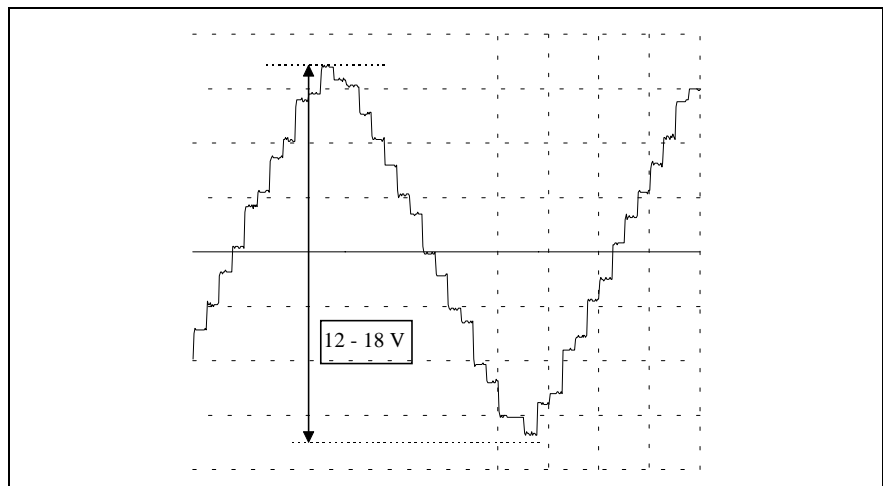
Figure 2-1: Methodically measured signal amplitude over AK: X31/1-2

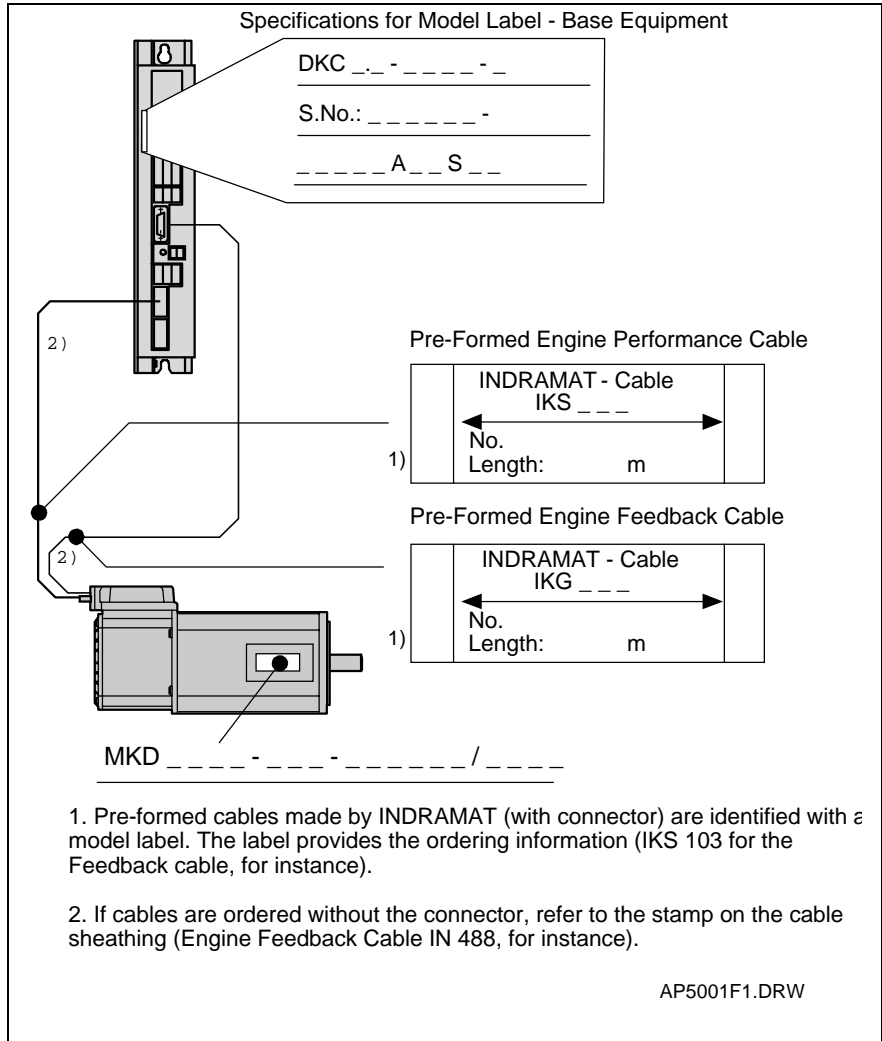
The identification plate for MKD motors is on the right side of the motor (when looking at the motor shaft with the motor connection box on top).

Assembled cables are supplied with a label (cable mark) that carries the cable number and the length of the assembled cable.

Figure 4-1: Type Description of the Drive Components

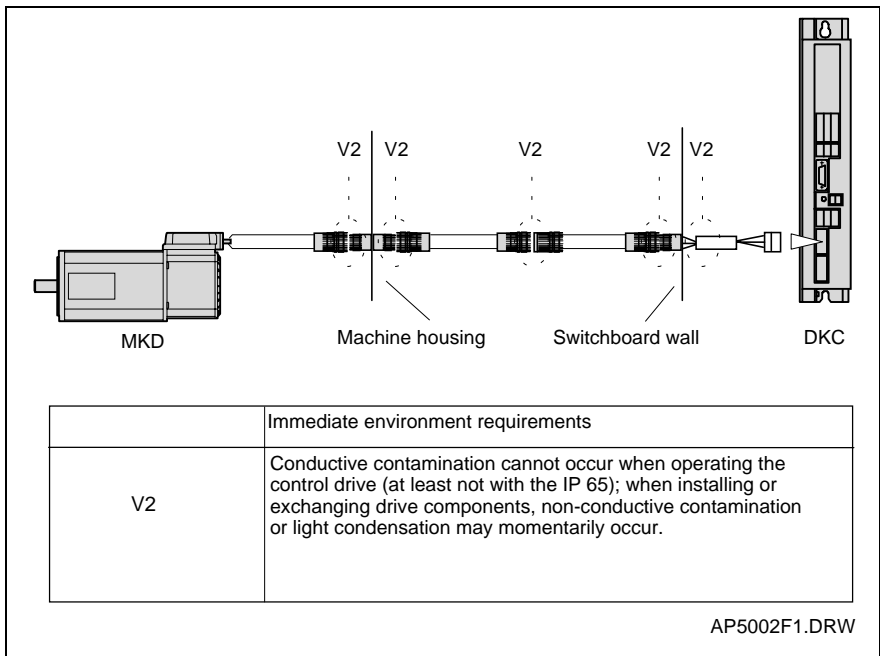
Note: When the cables are exchanged, open connectors from power connections should be closed with protection covers to protect against the spread of coolant, lubricating fluid or dirt (adm. protection level V2).

Figure 4-2: Contamination level according to DIN VDE 0160
