Success story Aditya Birla, Domsjö Fabriker

# Flexible solution leads to a quick start-up

# Rapid refurbishment of line for cellulose washer thanks to good cooperation and strong commitment

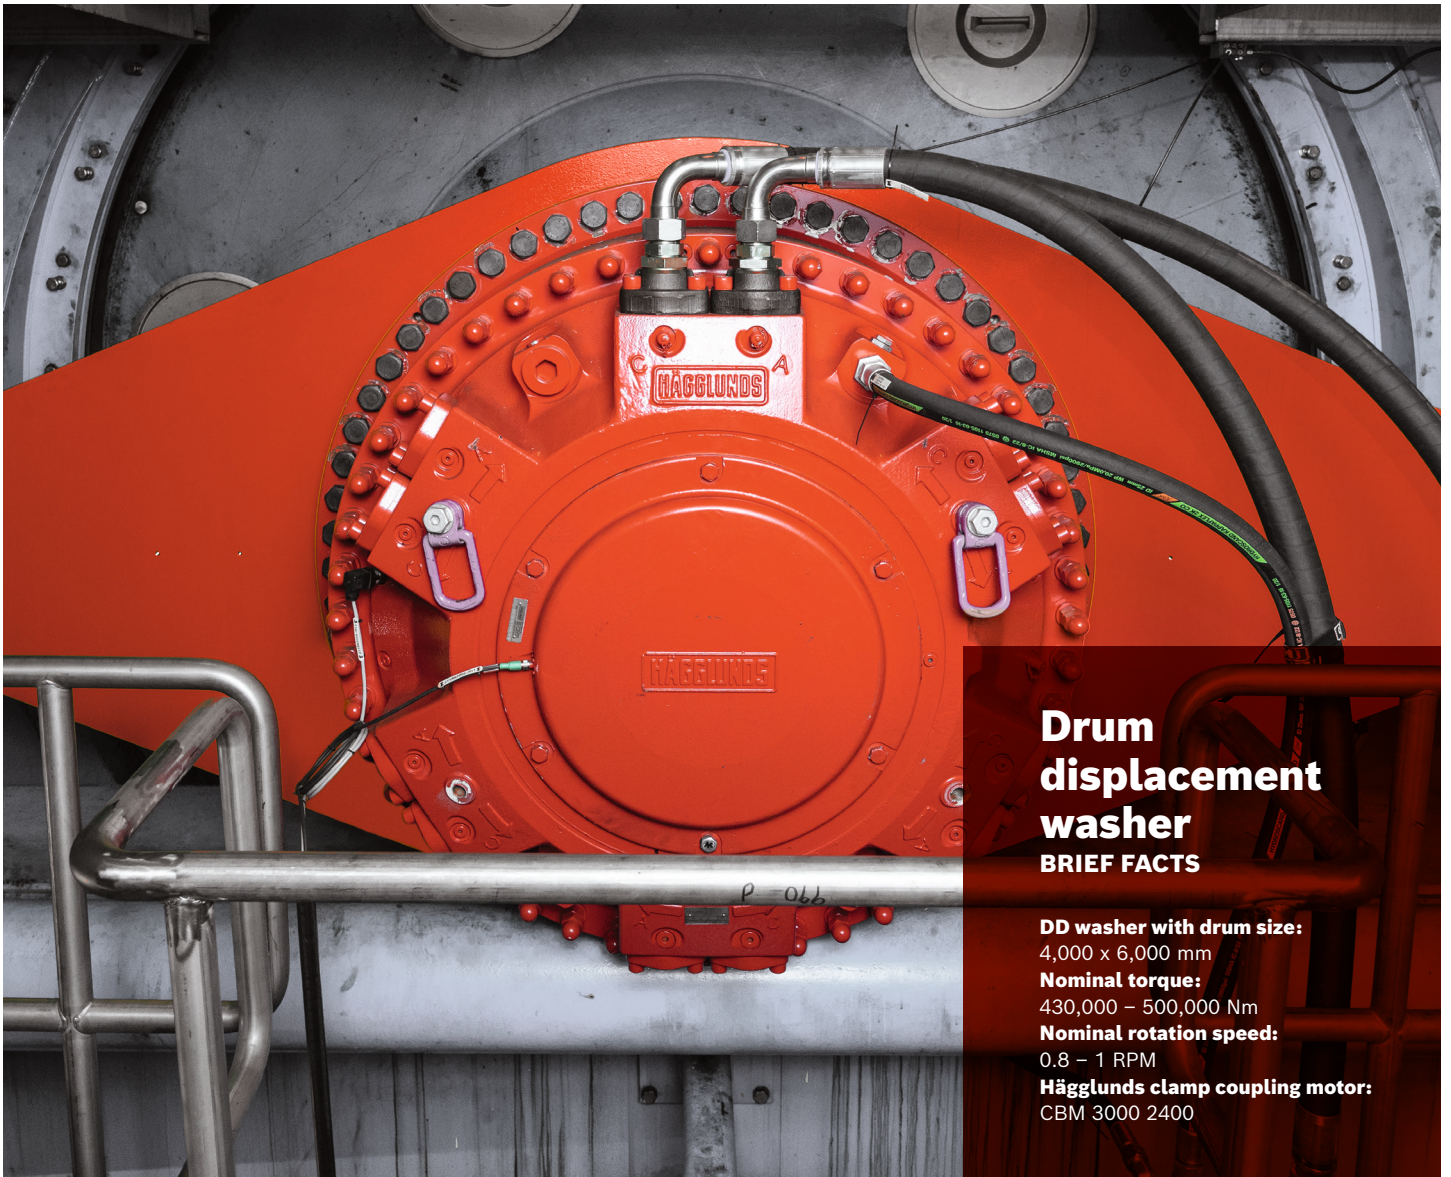
## Drum displacement washer

**DD washer with drum size:**

4,000 x 6,000 mm

**Nominal torque:**

430,000 – 500,000 Nm

**Nominal rotation speed:**

0.8 – 1 RPM

**Häggglunds clamp coupling motor:**

CBM 3000 2400

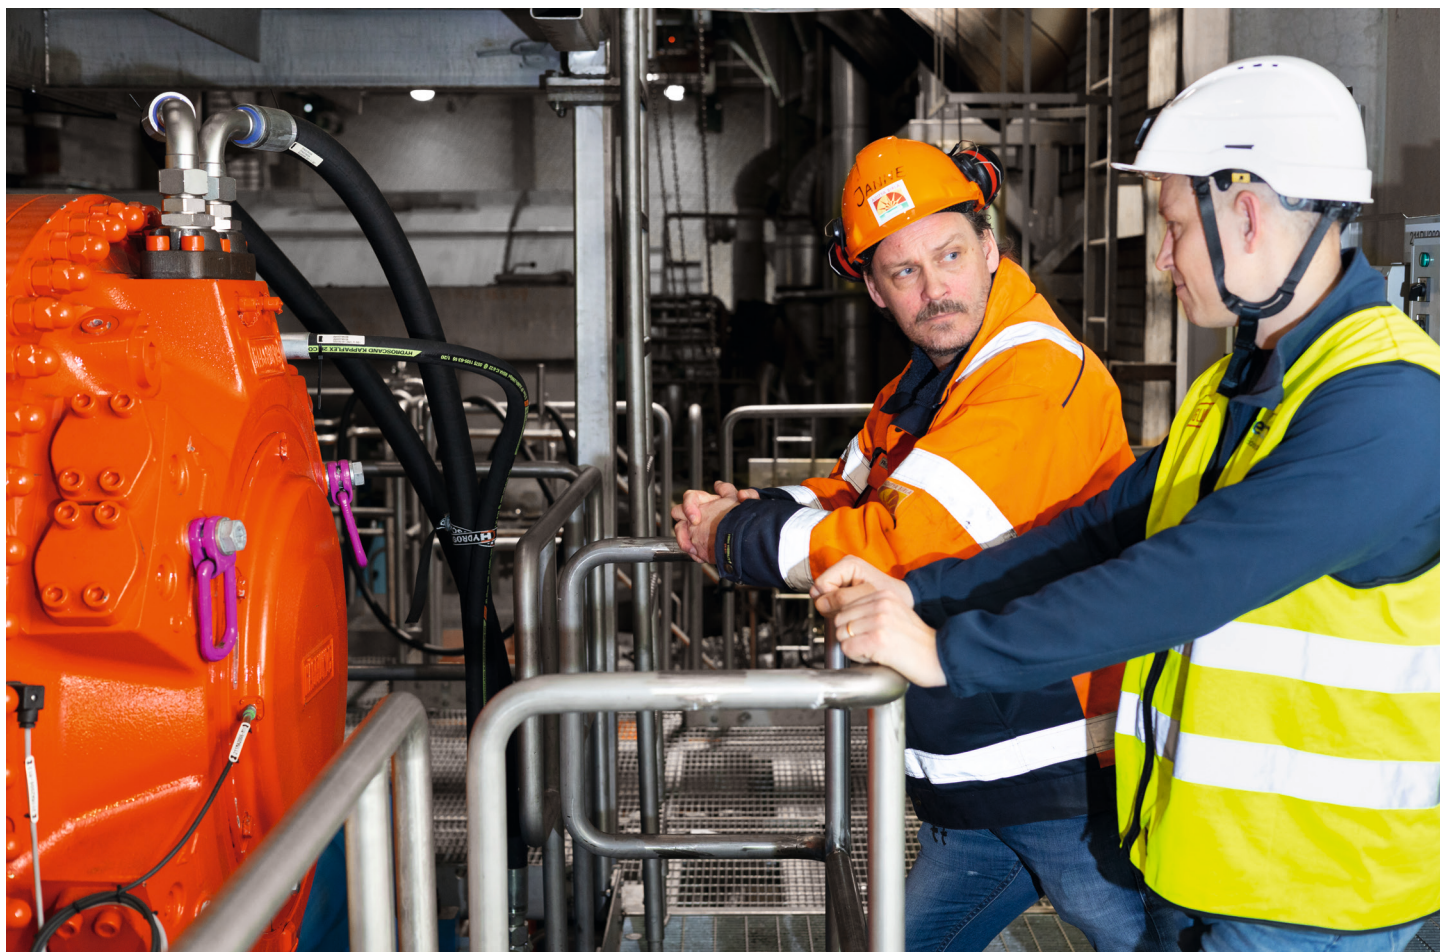
“We do everything to find a technical solution that suits the customer. In this case, we created an entirely new mounting for the torque arm within a short time, which fitted both existing equipment and our motor,” says Andreas Söderlund, sales manager for Hägglunds solutions. Here he discusses with Domsjö Fabriker’s maintenance manager Jan Nordlander.
